HOOSIC RIVER BASIN
NORTH ADAMS, MASSACHUSETTS

ECLIPSE DAM
MA 00279

PHASE I INSPECTION REPORT
NATIONAL DAM INSPECTION PROGRAM

MARCH 1980

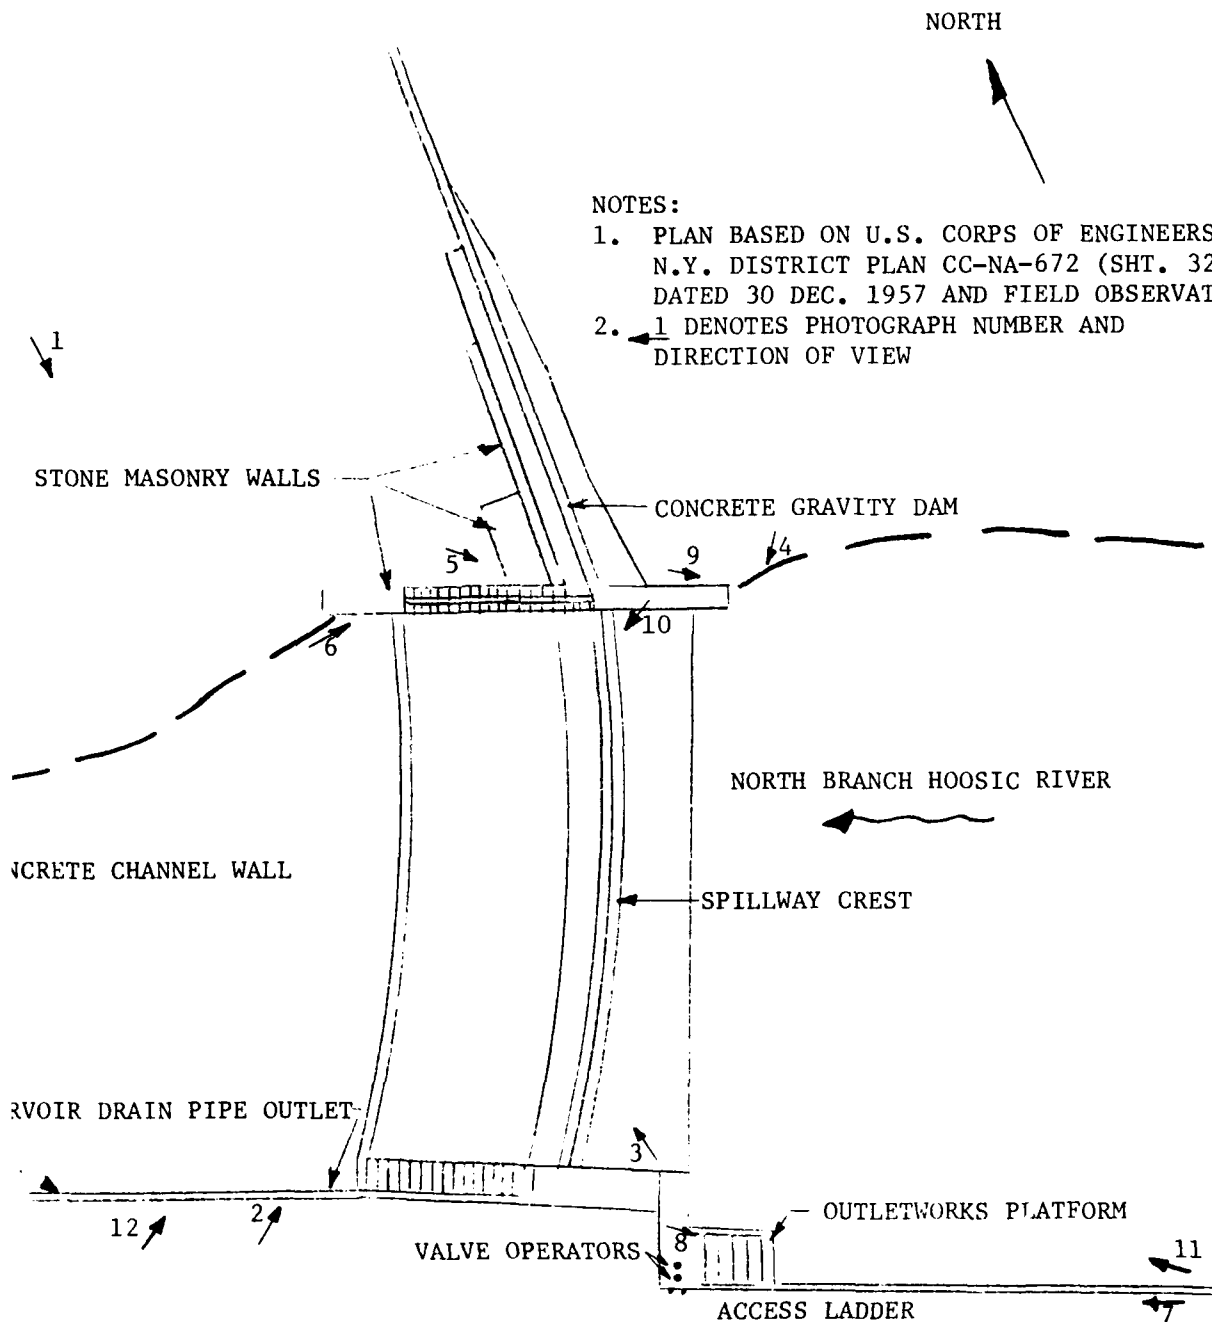
3. SPILLWAY RIGHT SIDE WALL WITH CONCRETE DAM IN BACKGROUND.
NOTE VOIDS AND TREE GROWTH IN SIDE WALL.

- (3) Remove small trees and vegetation from the stone masonry training walls.
- (4) Replace missing stones and mortar joints of loose stones in the exposed stone masonry.
